# Porsche Bank Fleet Management

Assessment criteria  
for returning utility vehicles

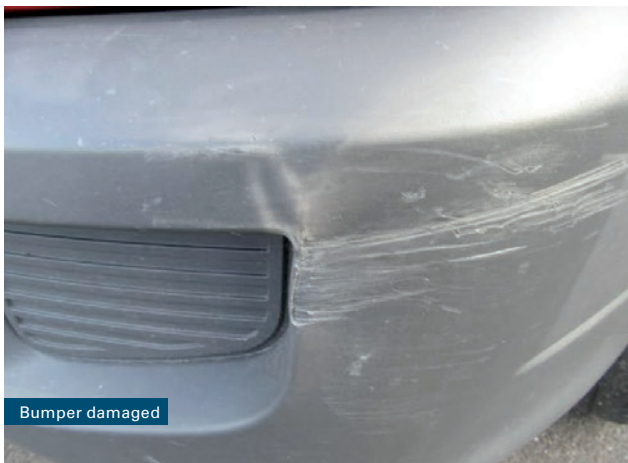
Bumper damaged

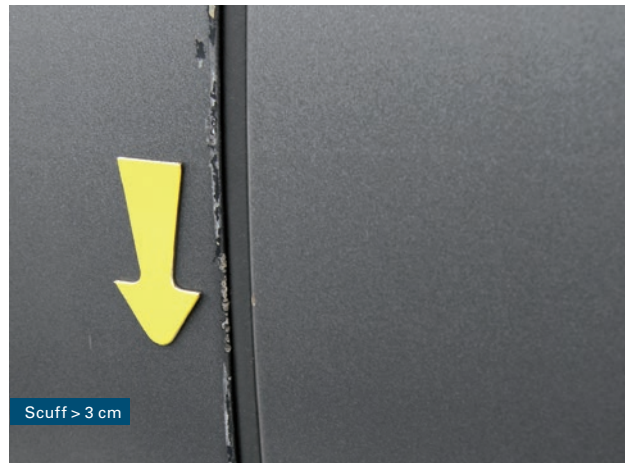
Scuff > 3 cm

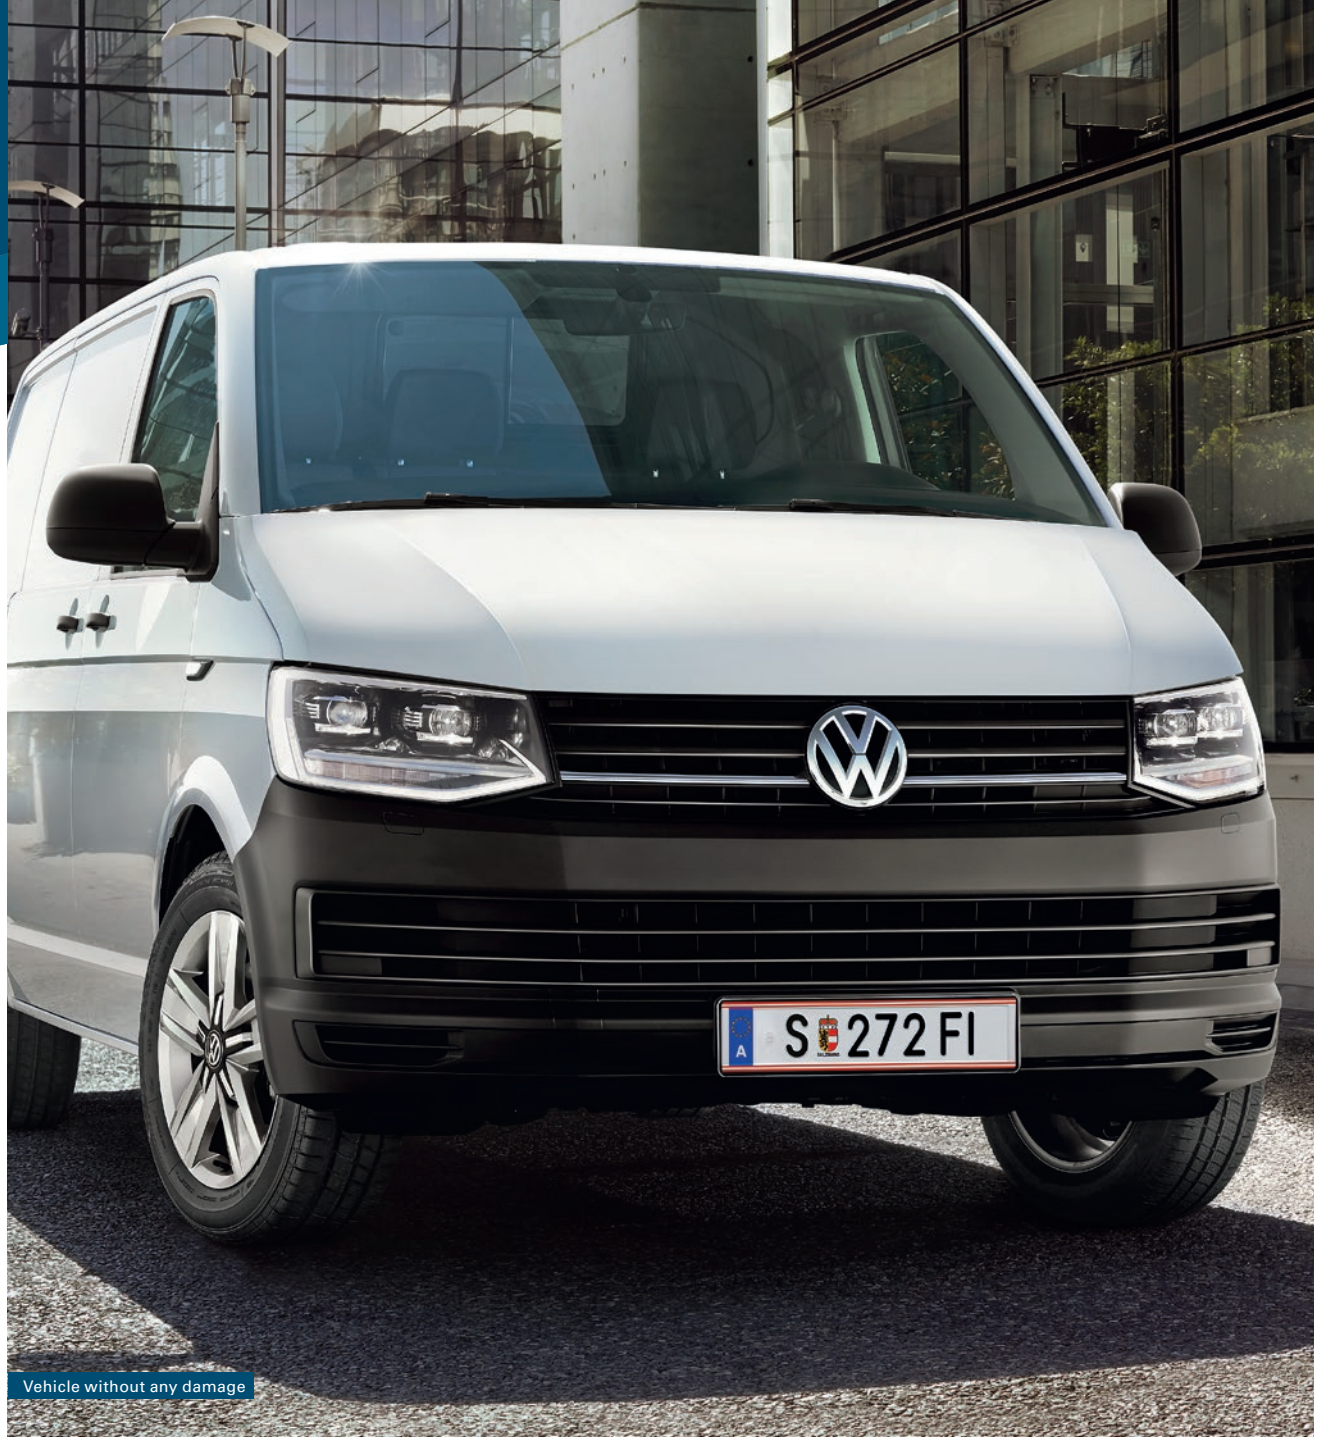
Vehicle without any damage

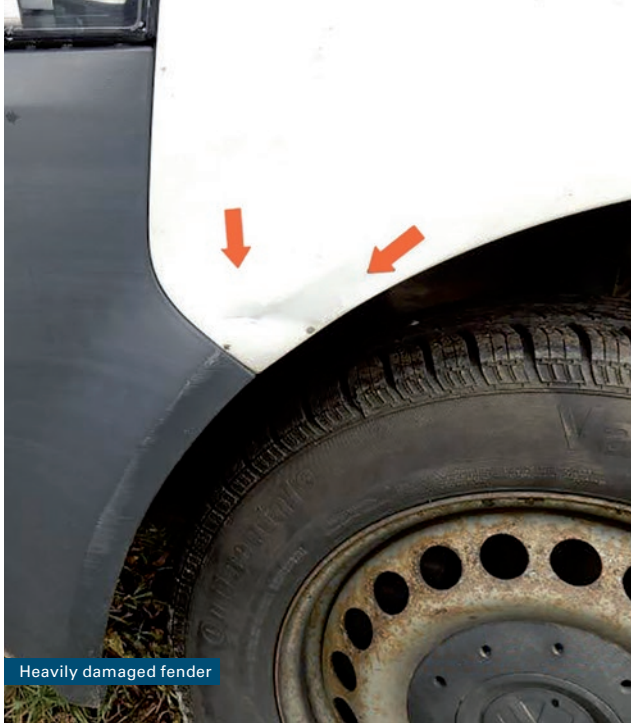
Heavily damaged fender

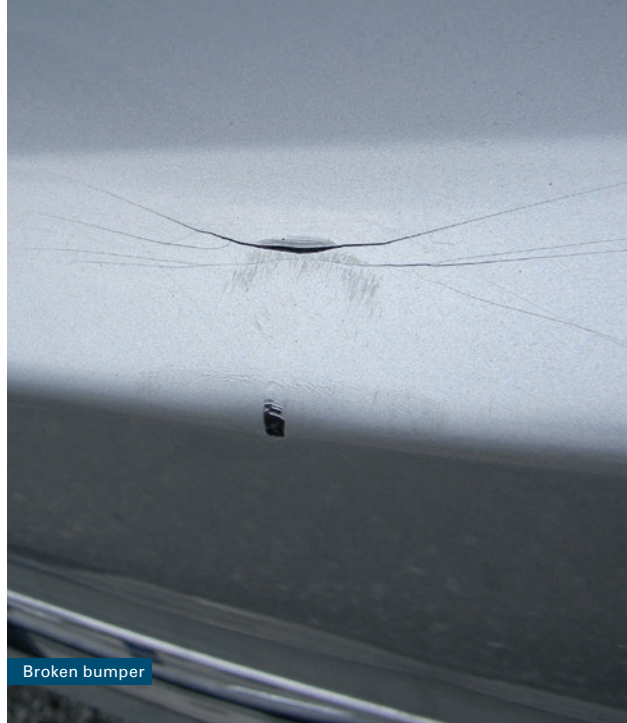
Broken bumper

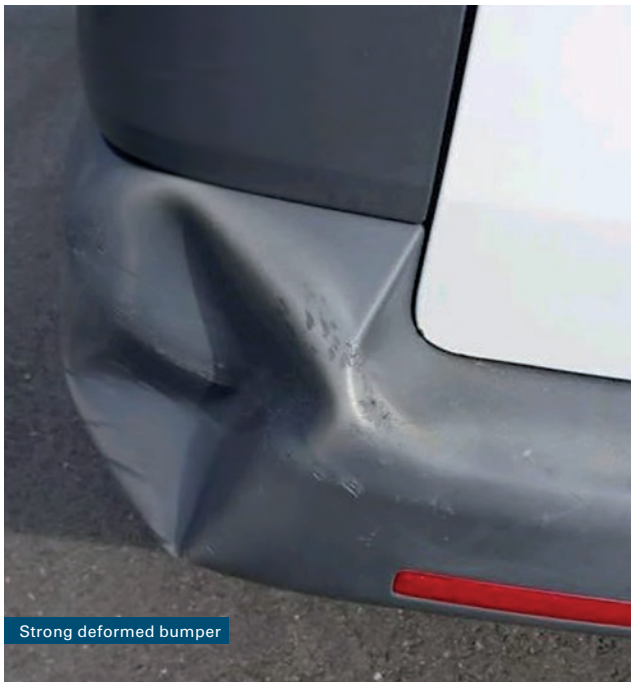
Strong deformed bumper

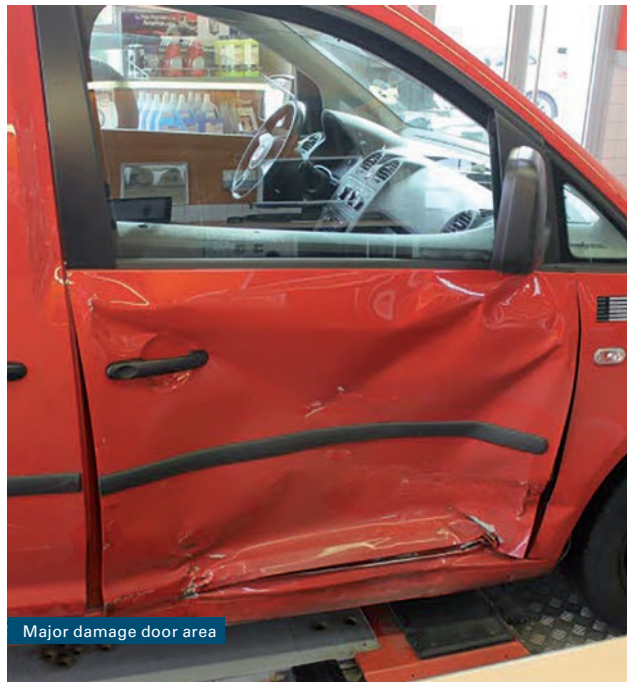
Major damage door area

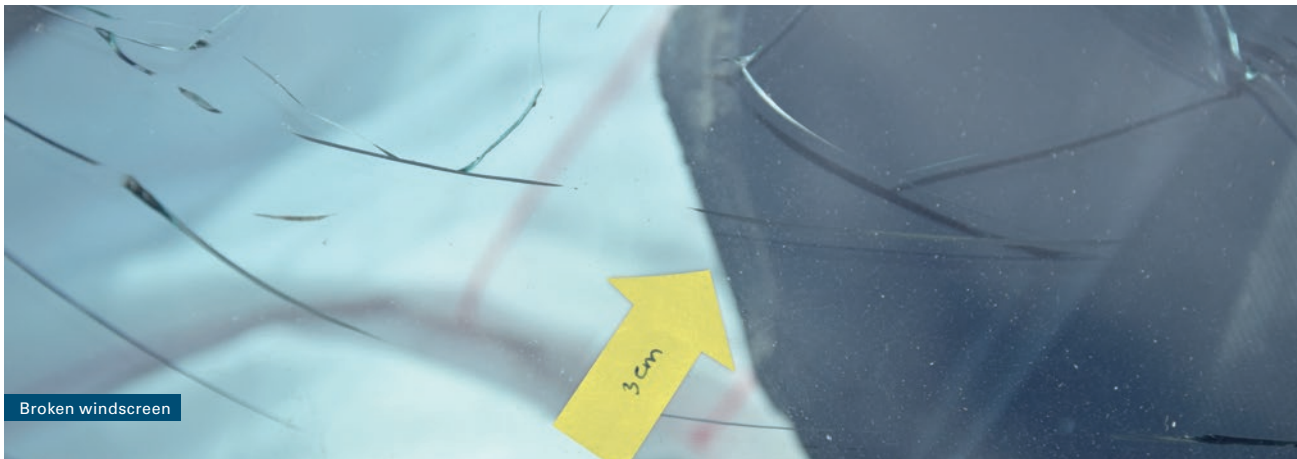
Broken windscreen

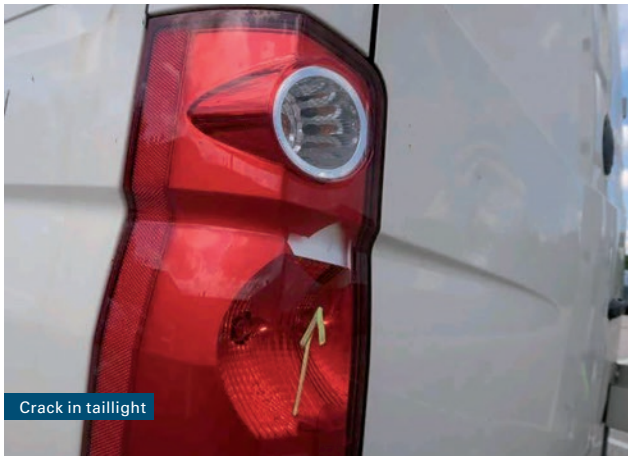
Crack in taillight

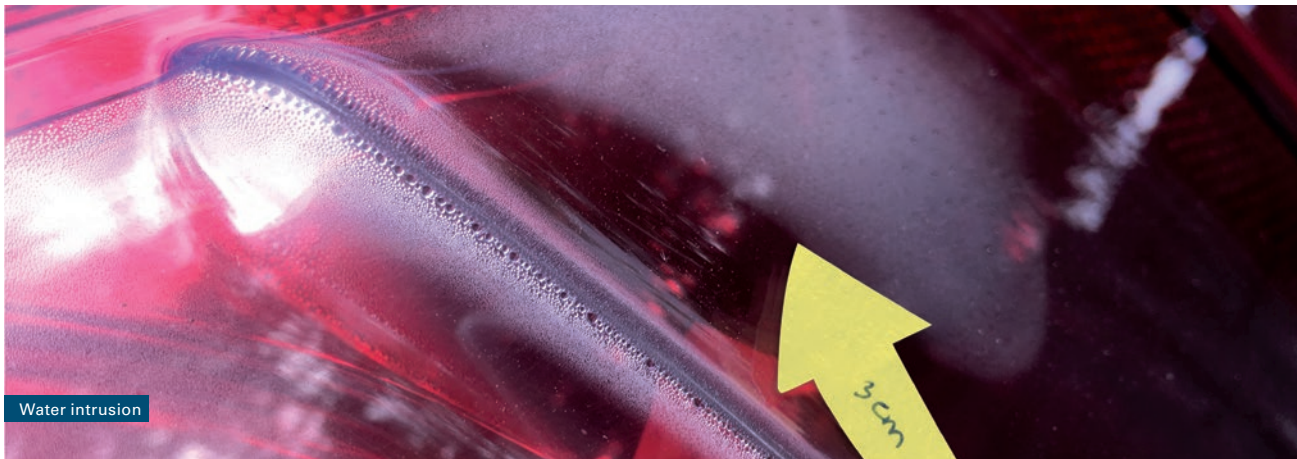
Water intrusion

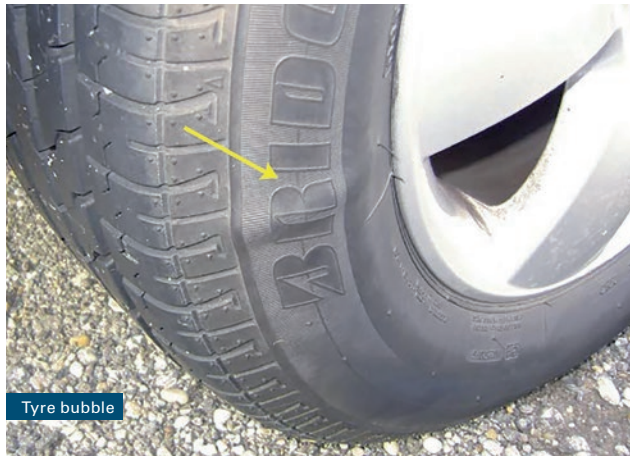
Tyre bubble

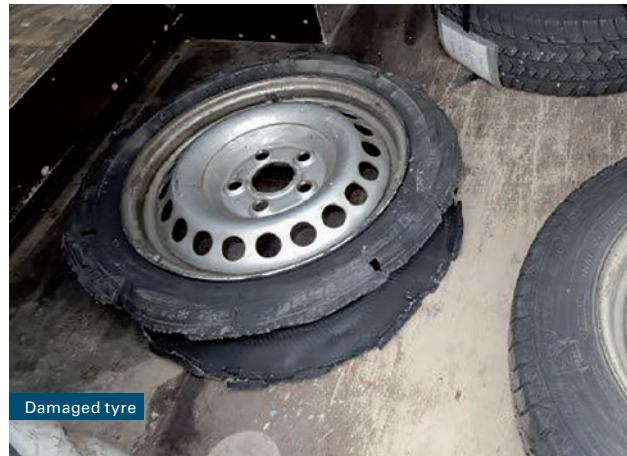
Damaged tyre

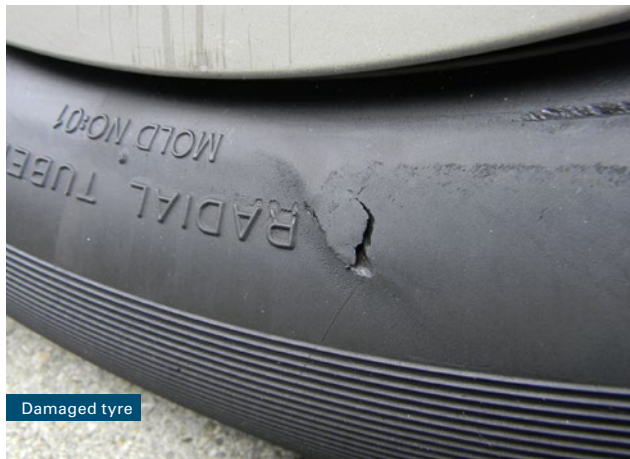
Damaged tyre

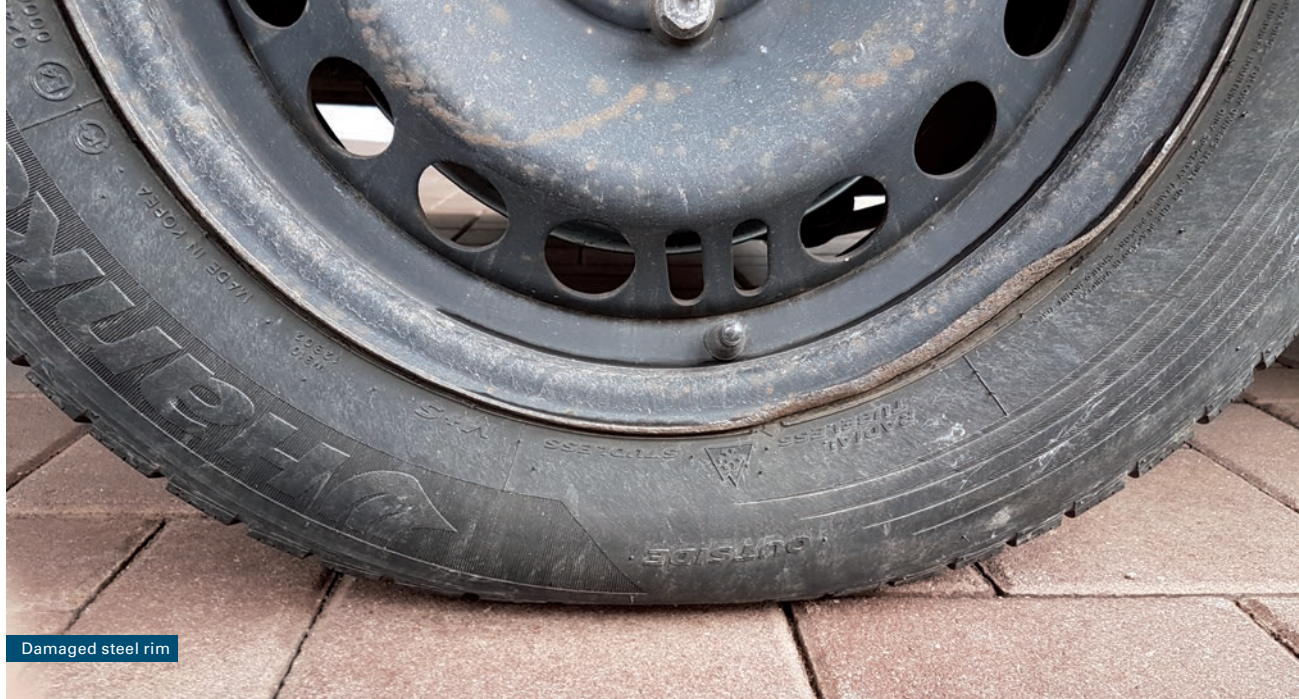
Damaged steel rim

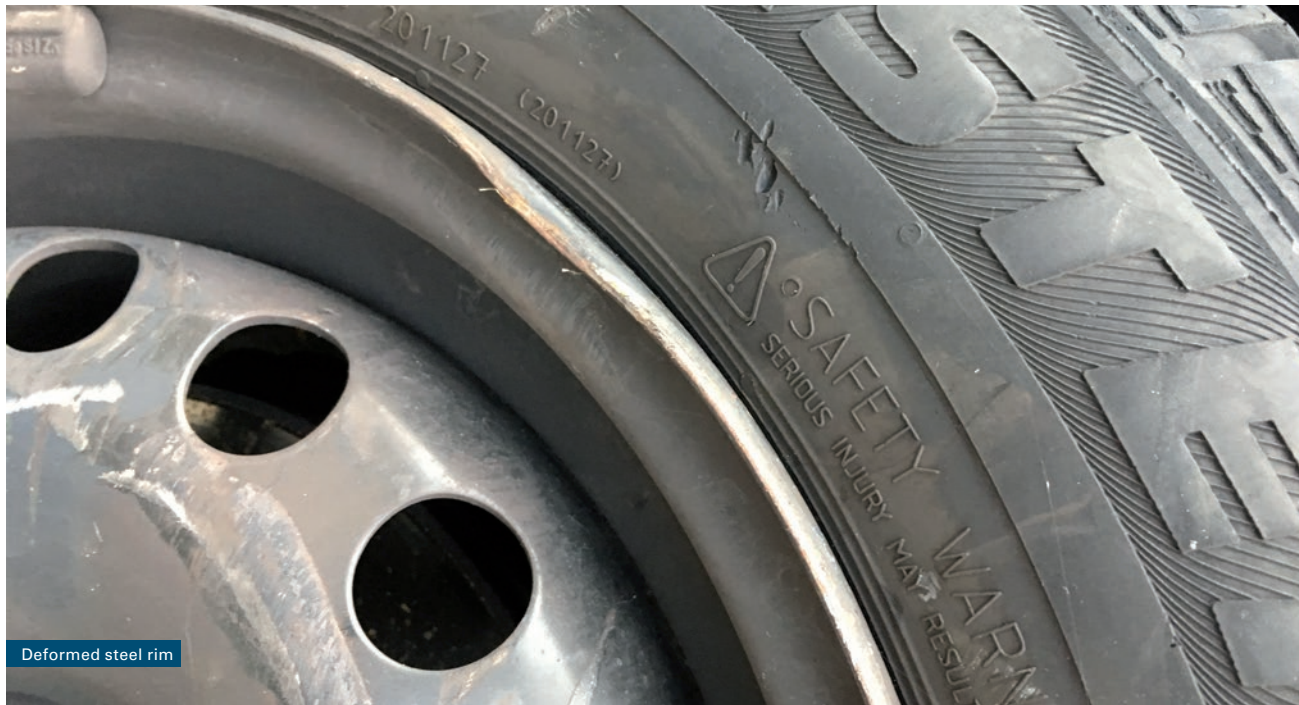
Deformed steel rim

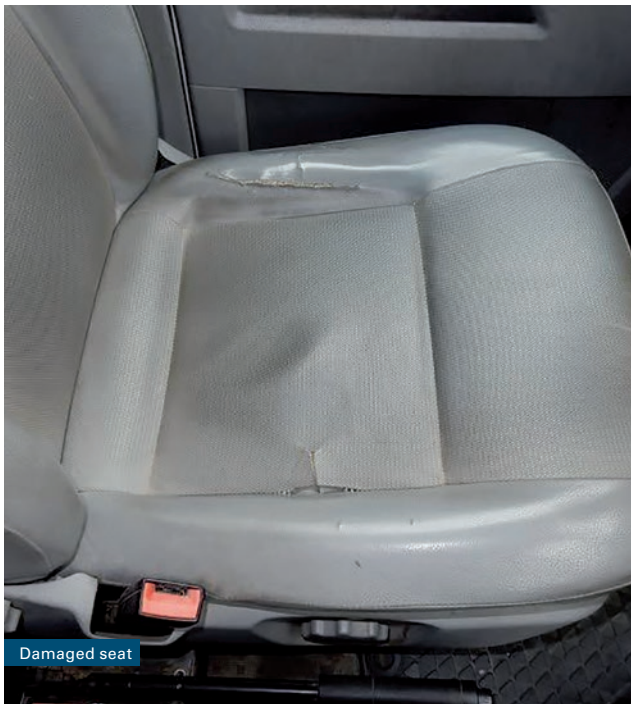
Damaged seat

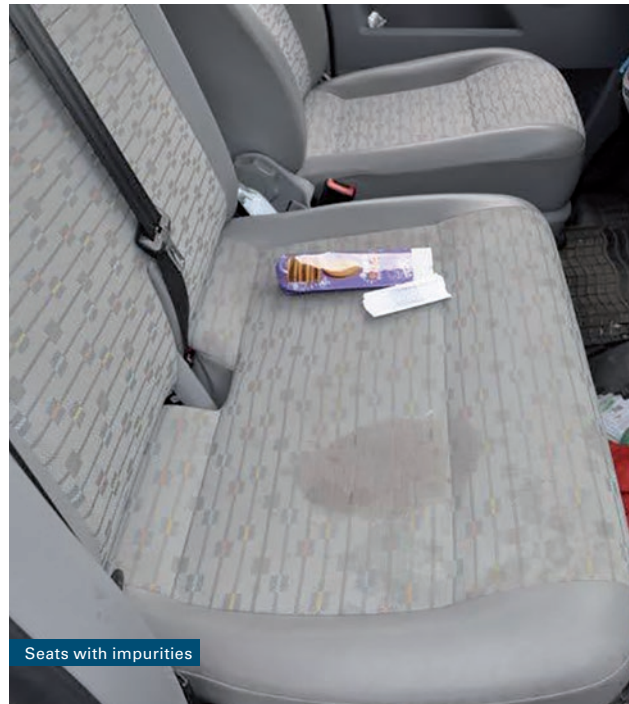
Seats with impurities

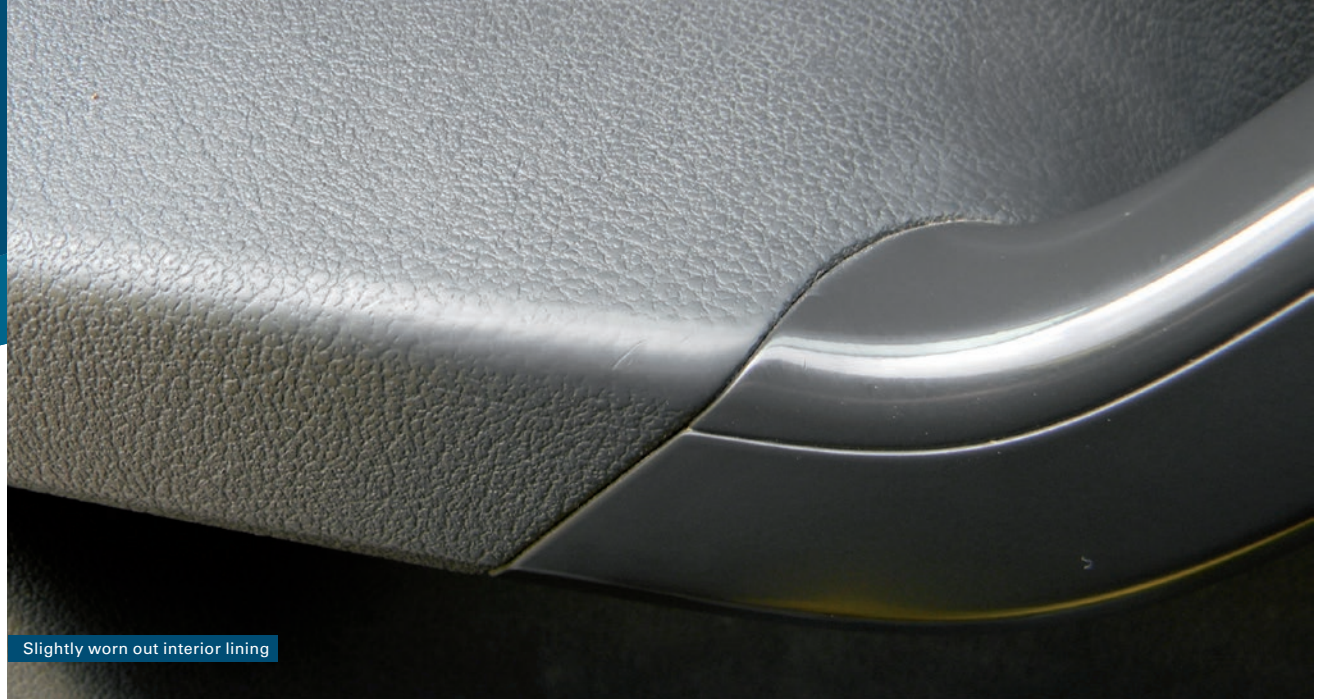
Slightly worn out interior lining

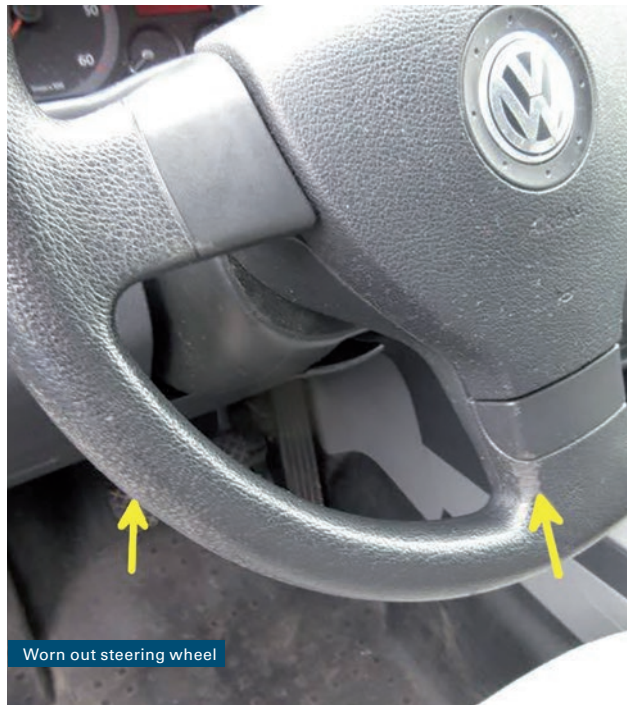
Worn out steering wheel

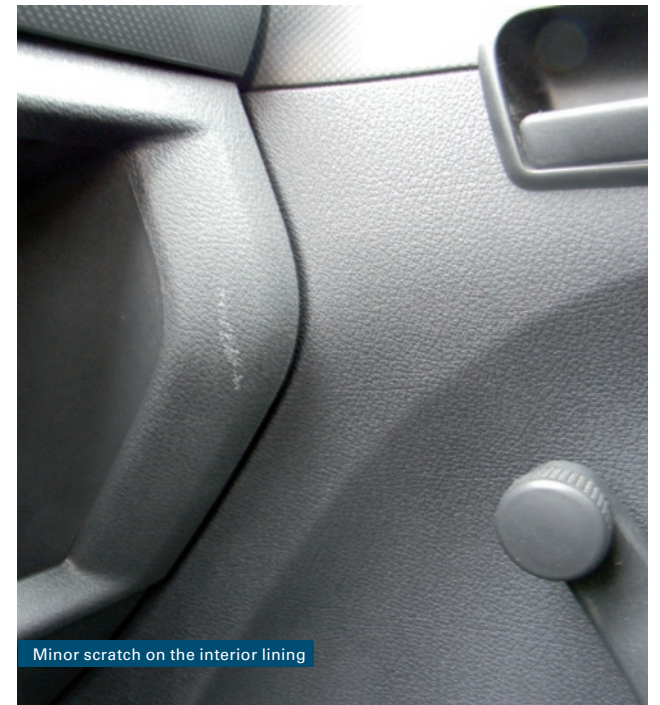
Minor scratch on the interior lining

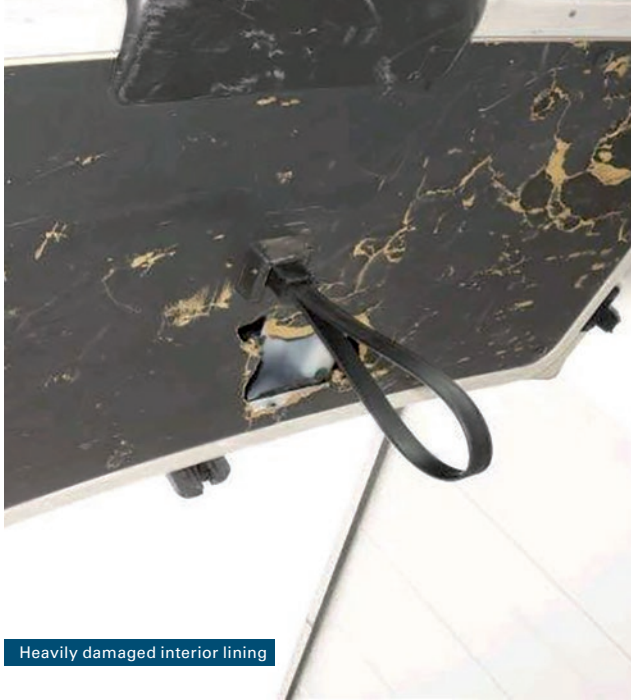
Heavily damaged interior lining

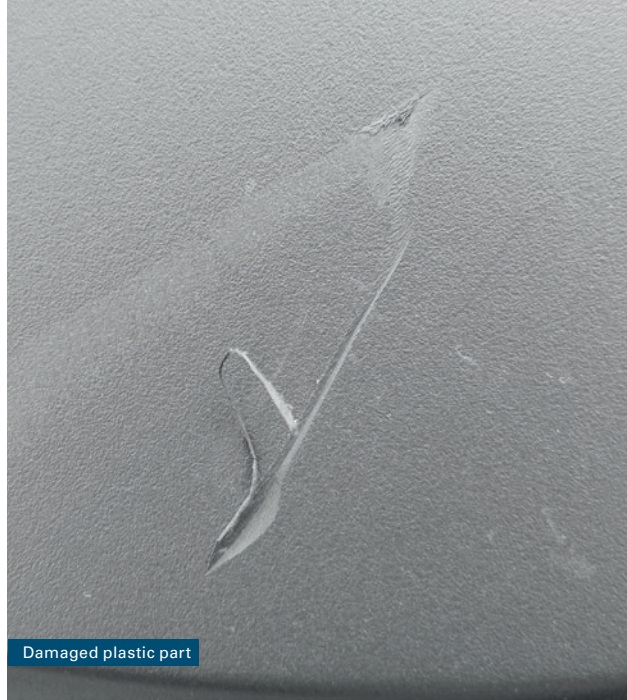
Damaged plastic part

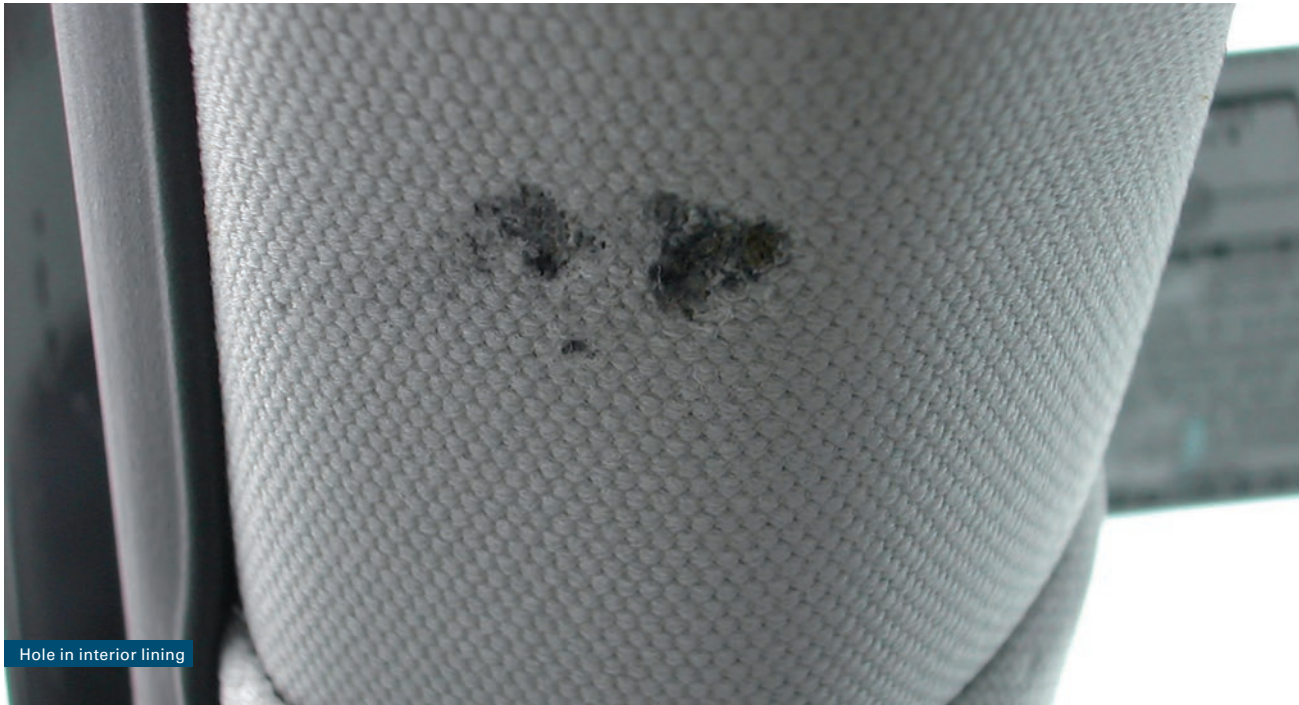
Hole in interior lining

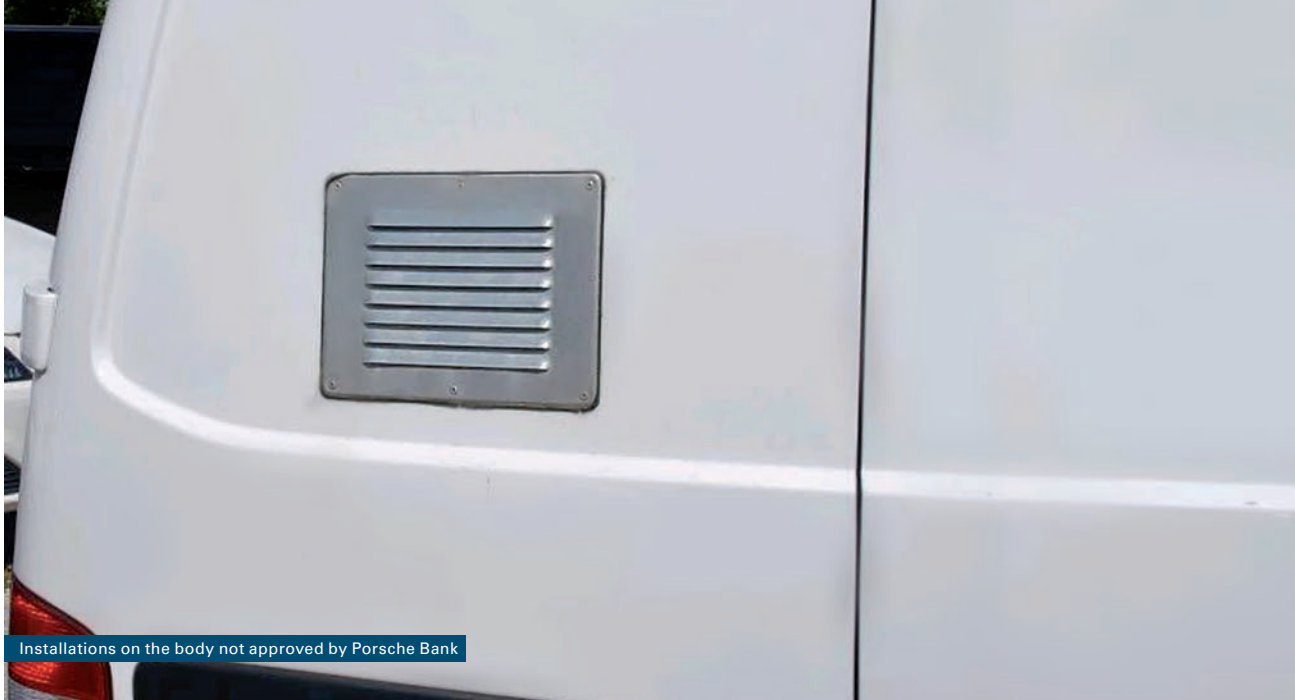
Installations on the body not approved by Porsche Bank

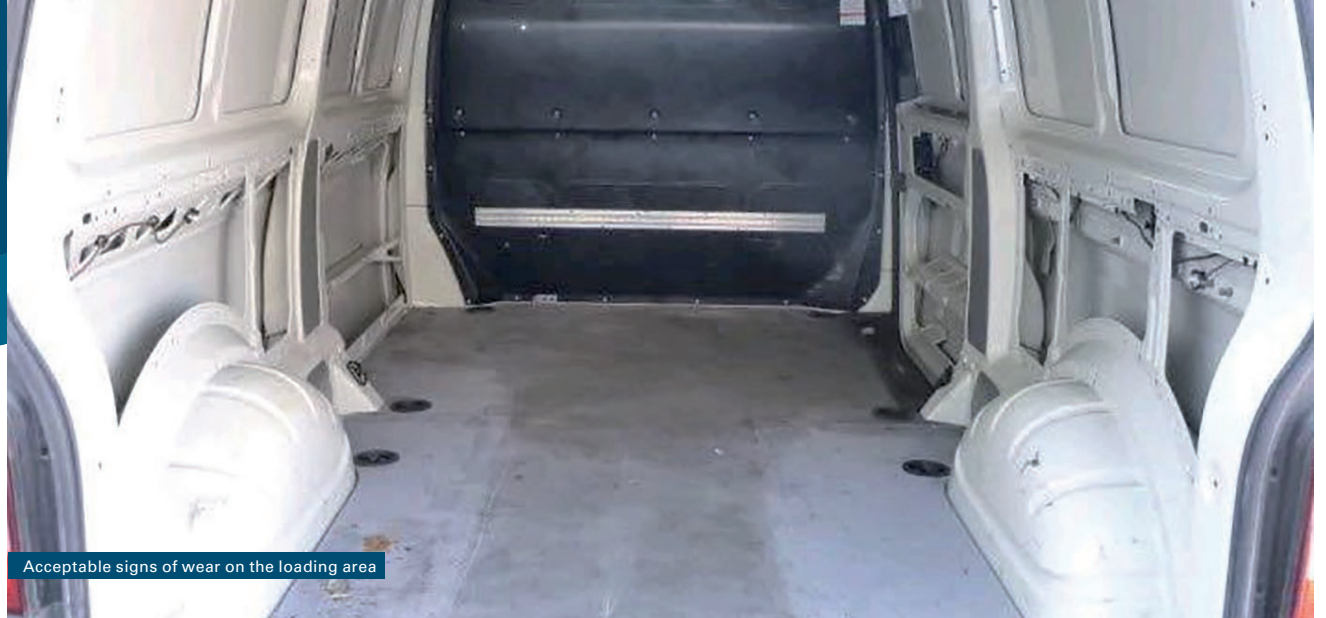
Acceptable signs of wear on the loading area

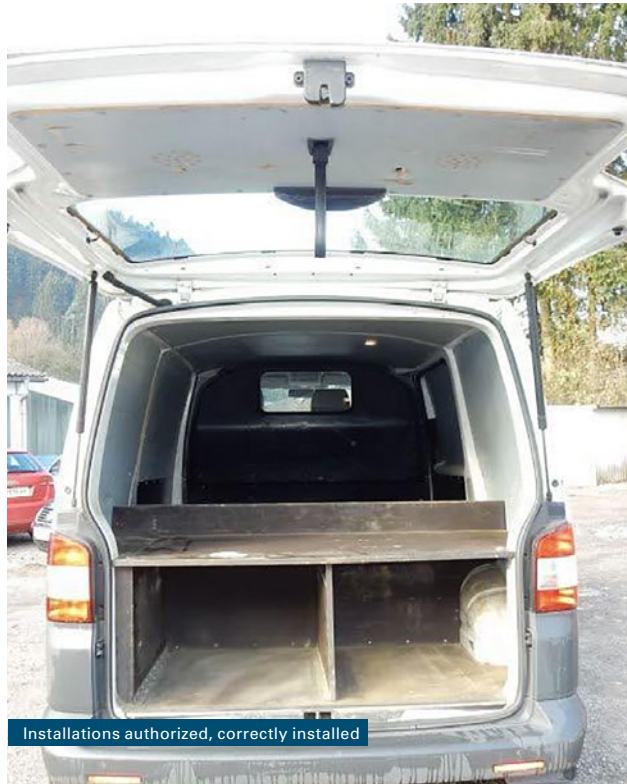
Installations authorized, correctly installed

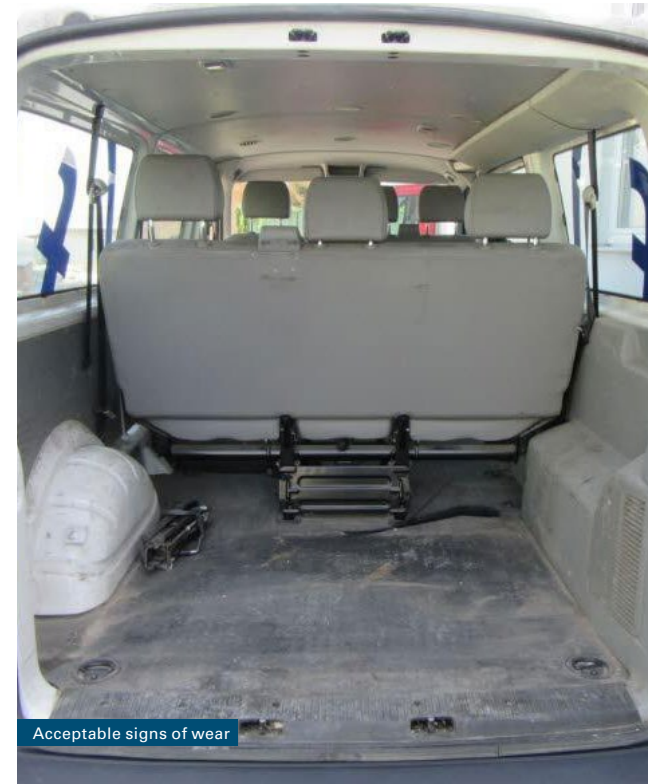
Acceptable signs of wear

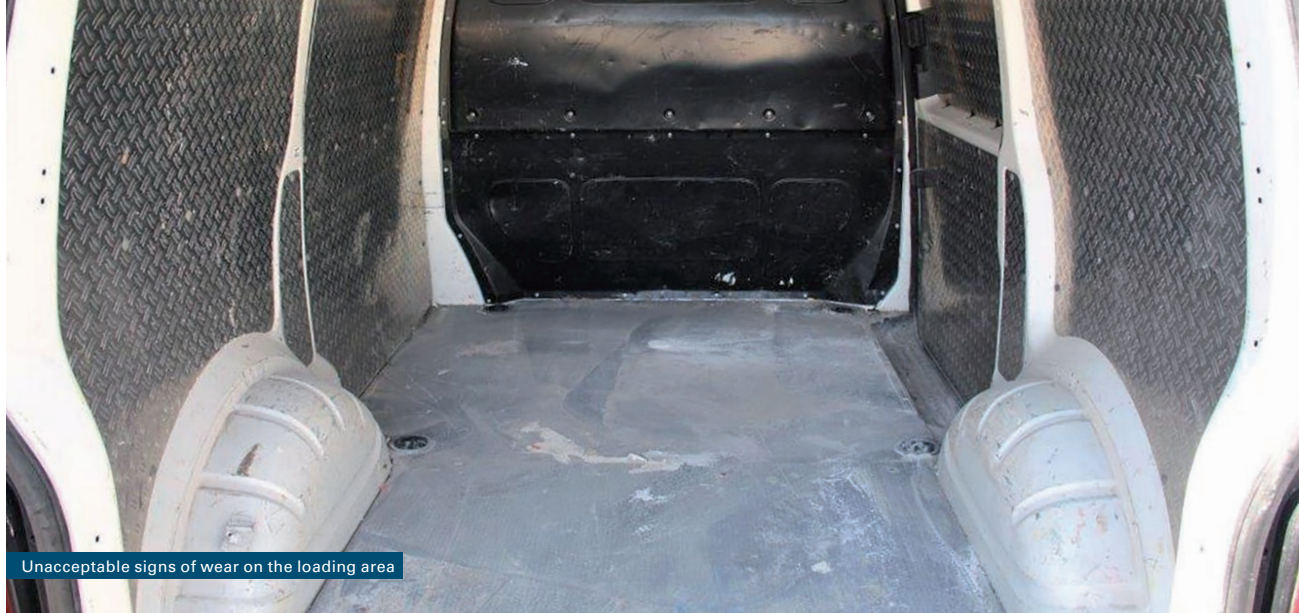
Unacceptable signs of wear on the loading area

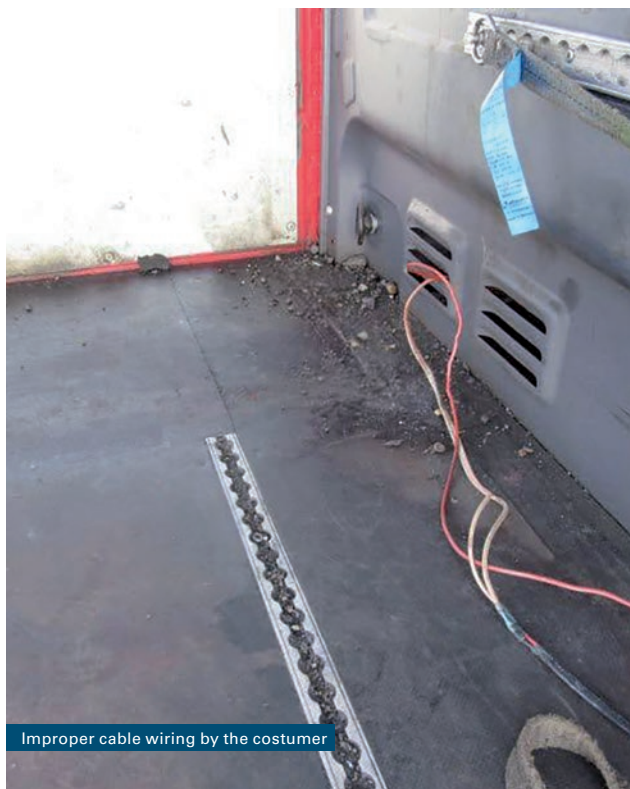
Improper cable wiring by the costumer

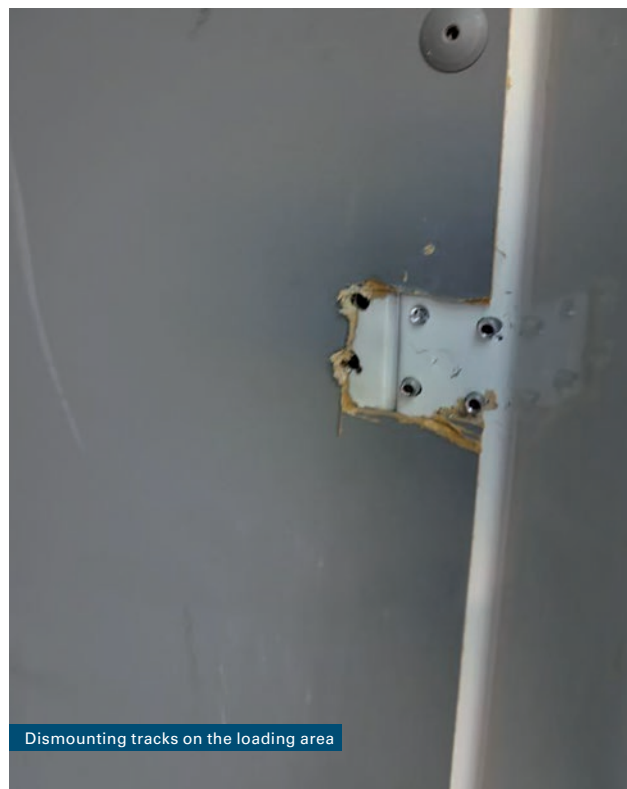
Dismounting tracks on the loading area
